Table 3-12
Buildings with Known Asbestos
MCAS El Toro BCP - March 1995

Table 3-13
Summary of SWMUs/AOCs
MCAS El Toro BCP - March 1995

Installation-Wide Strategy For Environmental Restoration

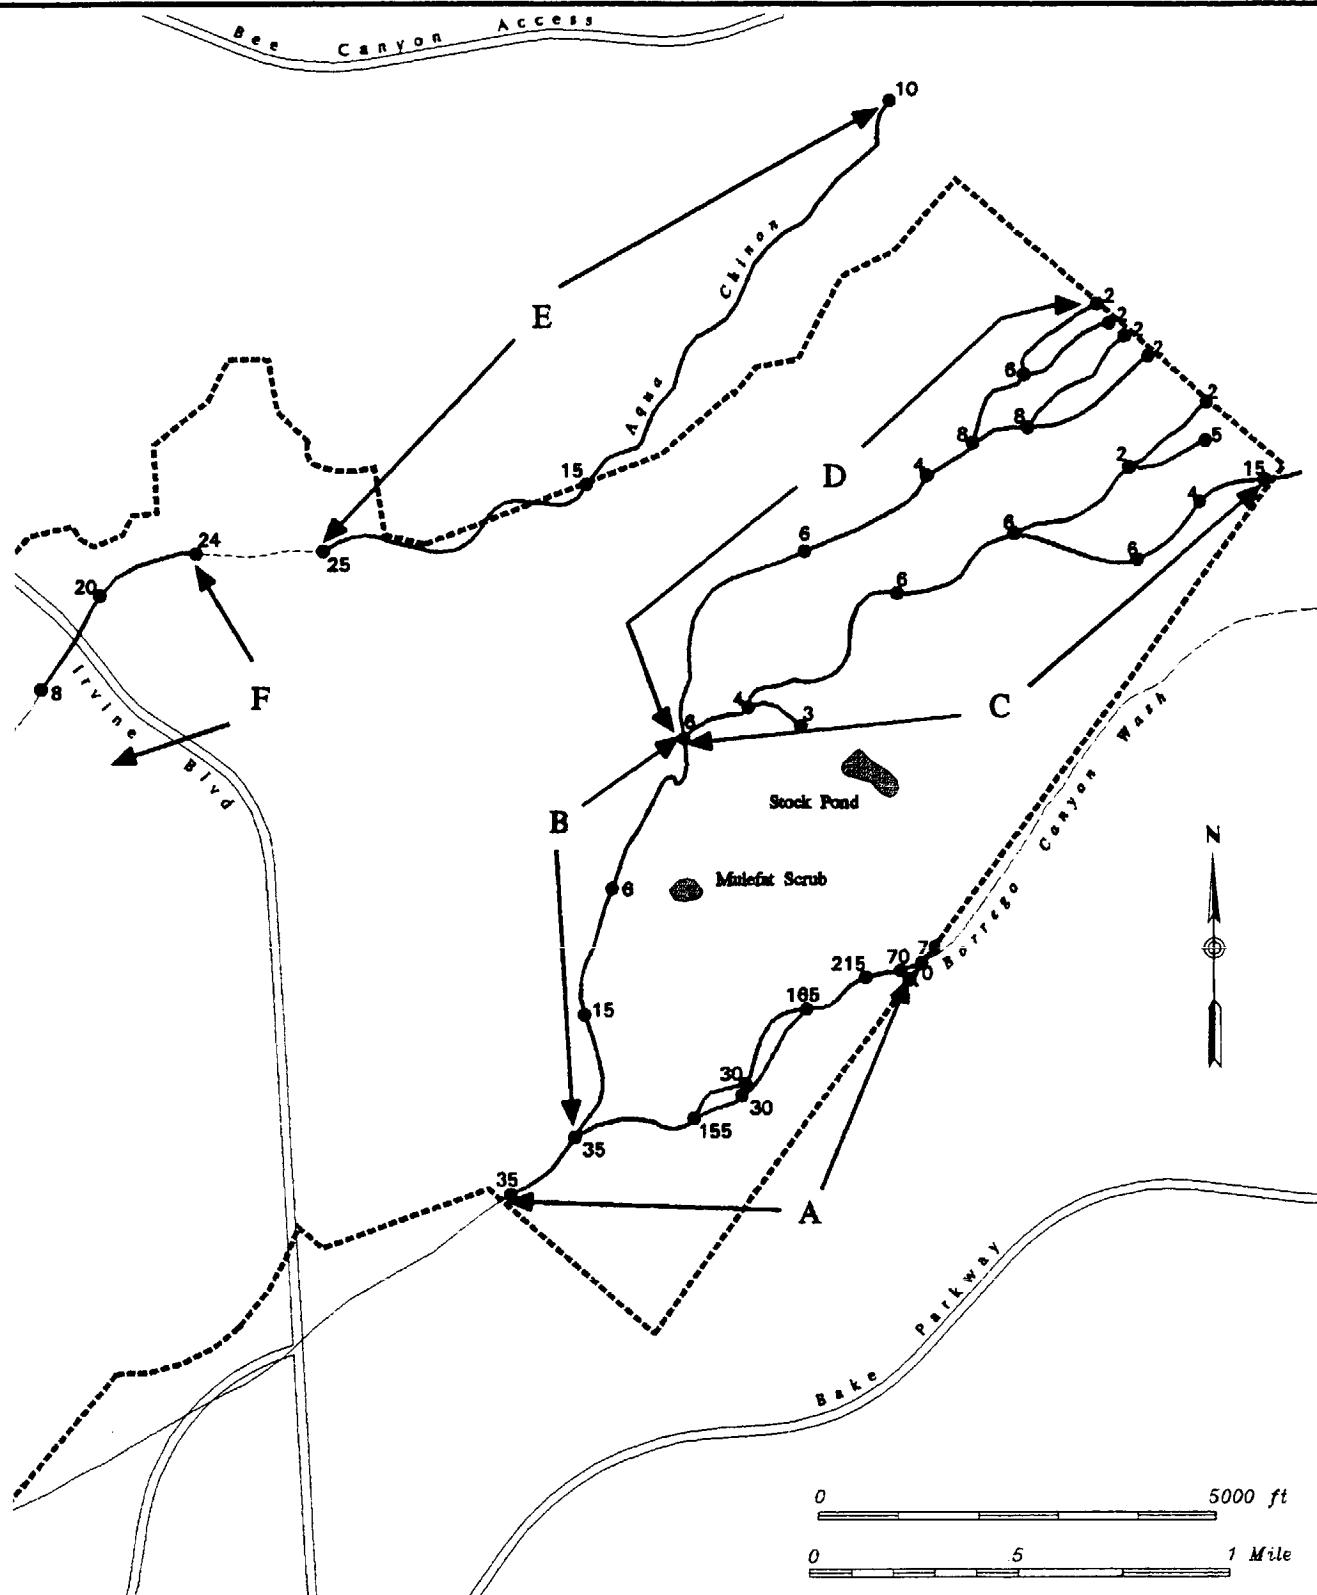
FIGURE 3-3b
WETLANDS AND WATERS
IN NATURAL AREA

----- underground channel
 ————— lined channel
 - . - . - unlined channel
 [shaded box] wetlands
 ● 5 channel width in feet

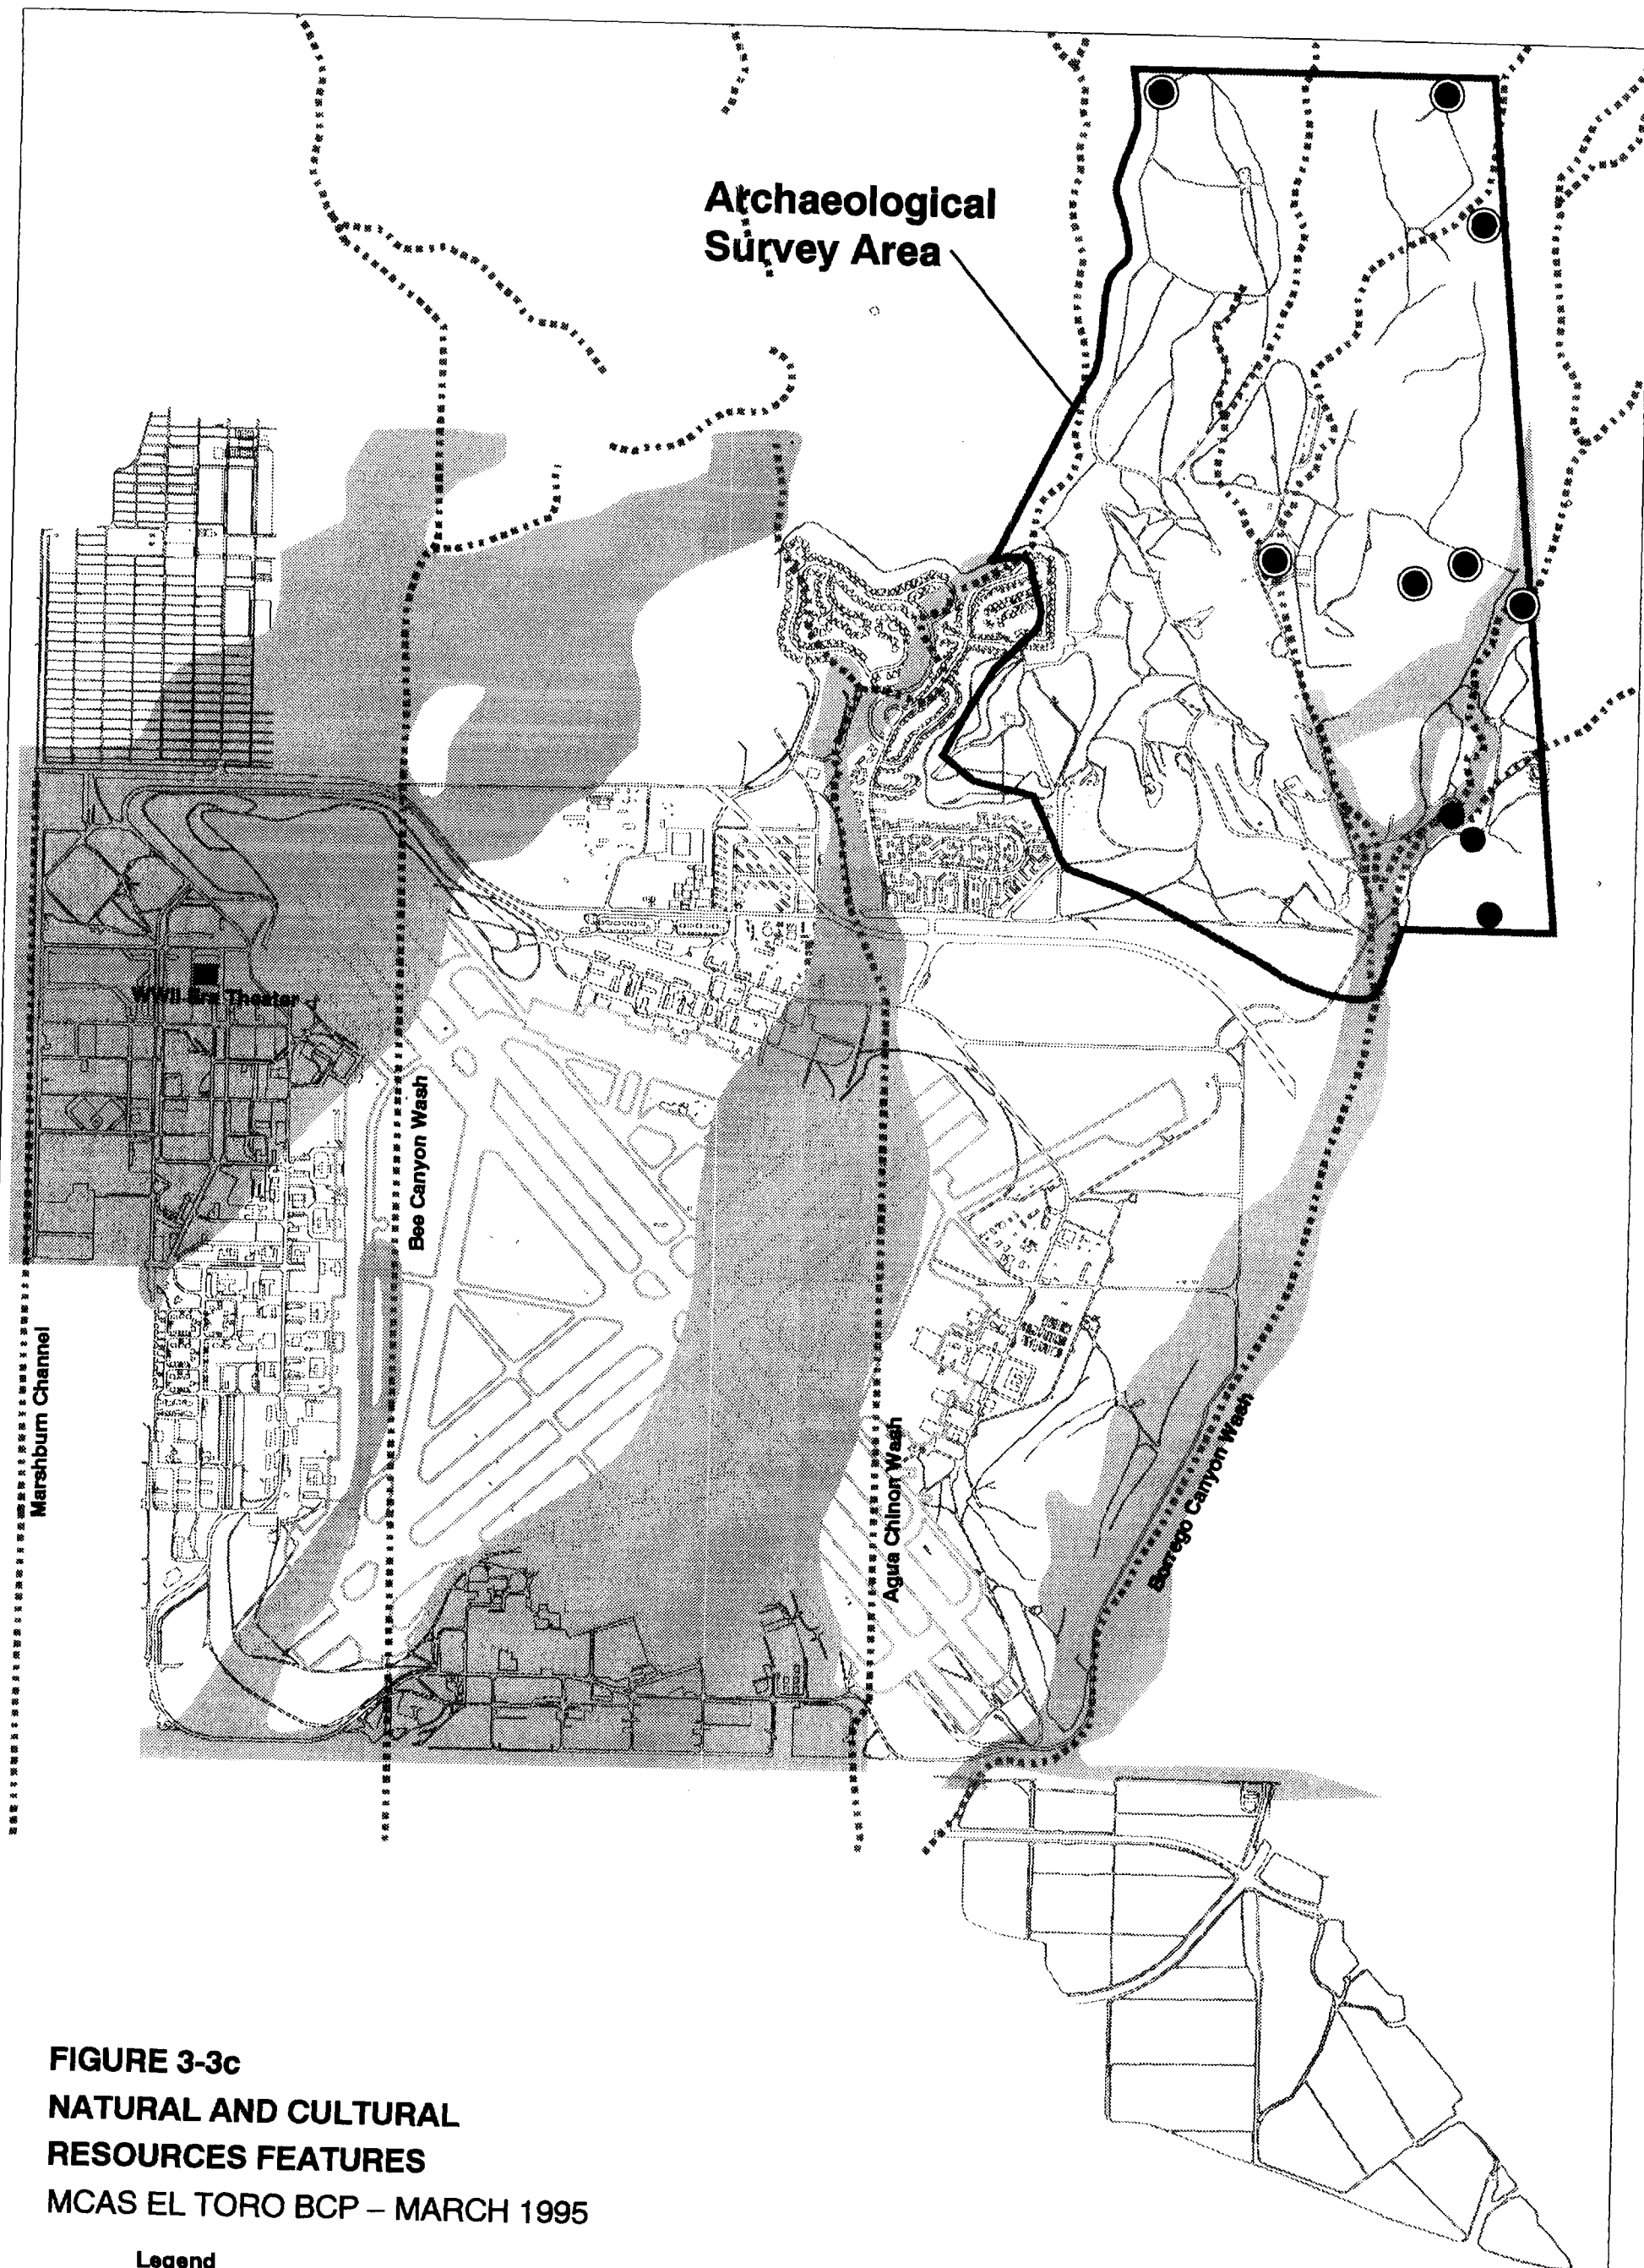
FIGURE 3-3c
NATURAL AND CULTURAL
RESOURCES FEATURES
 MCAS EL TORO BCP – MARCH 1995

- Archaeological Sites
- Archaeological Sites Recommended for Further Evaluation for Eligibility for Nomination to the National Register of Historic Places
- 100-Year Floodplain
